Electric Line Clearance Management Plan

2025 - 2026

Doc. No:	ECLMP
Rev. No.:	2.8
Rev. Date:	March 2025

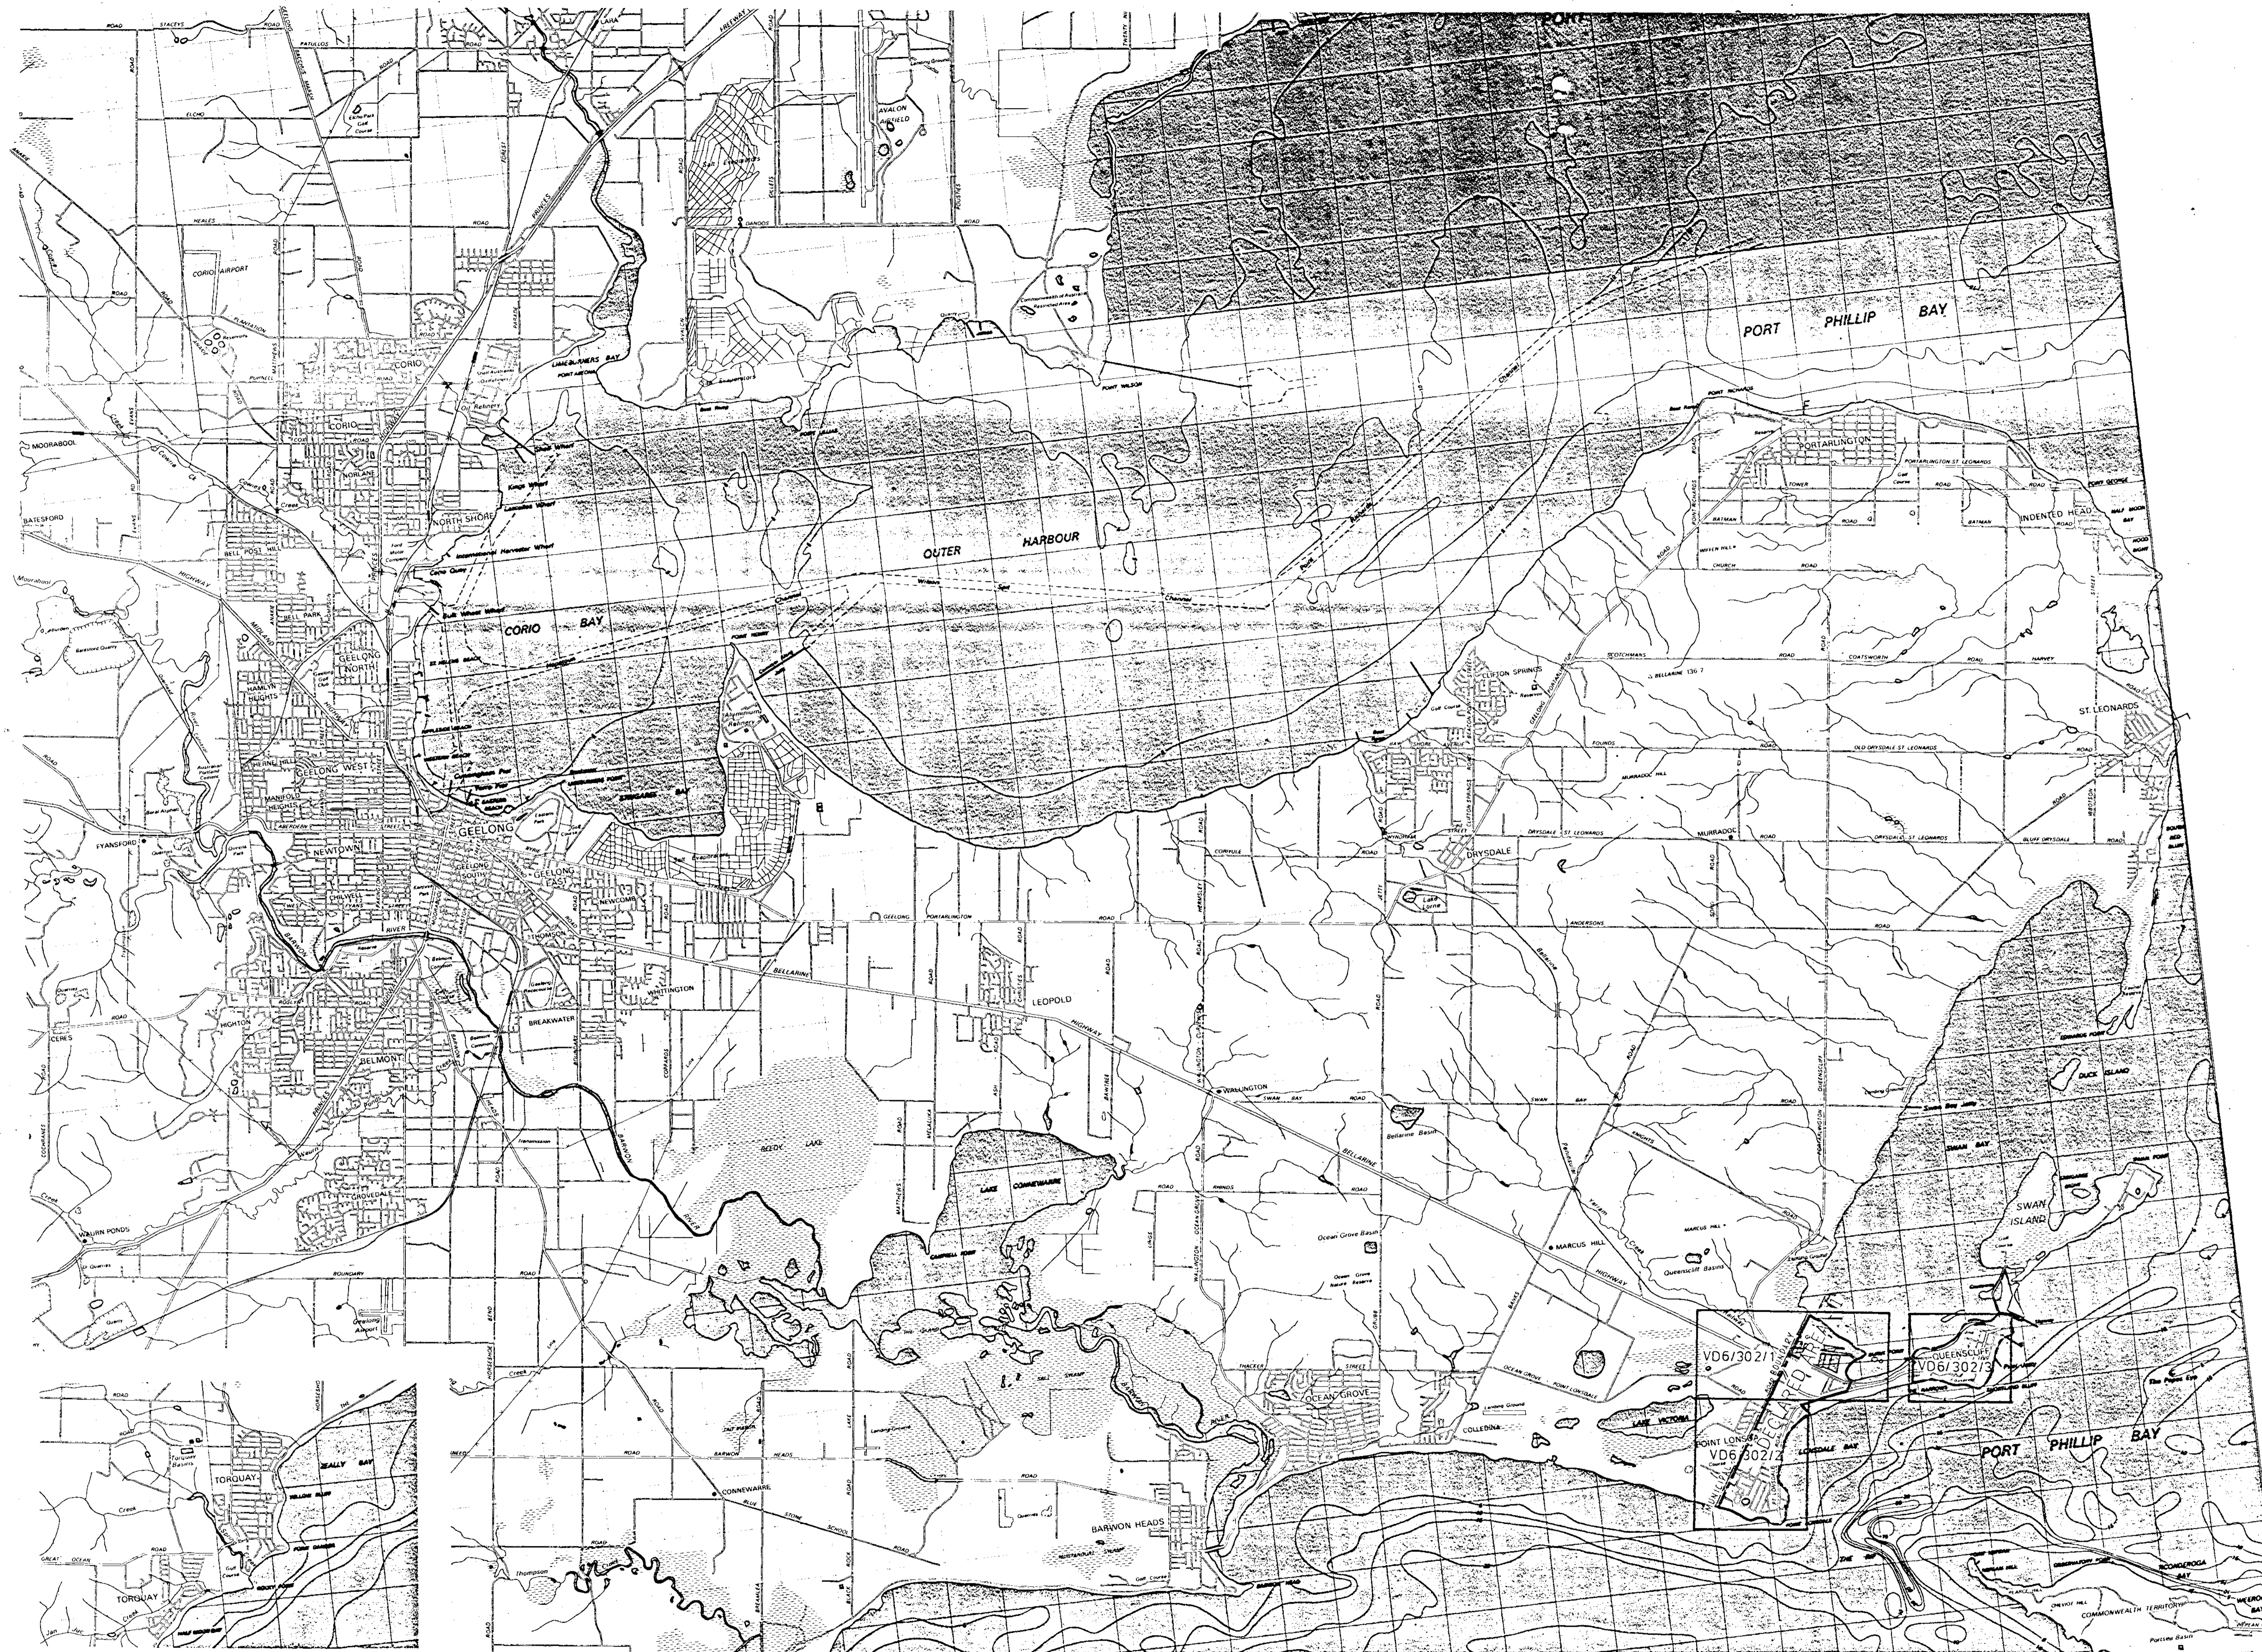
Appendix 19 BOQ ELCMP

This map being State Electricity Commission of Victoria number V06/302 SERIES is the index sheet to Commission Drawings depicting the boundaries of the land which has been or is to be declared under Section 65 (3)(4) of the State Electricity Commission Act 1958.

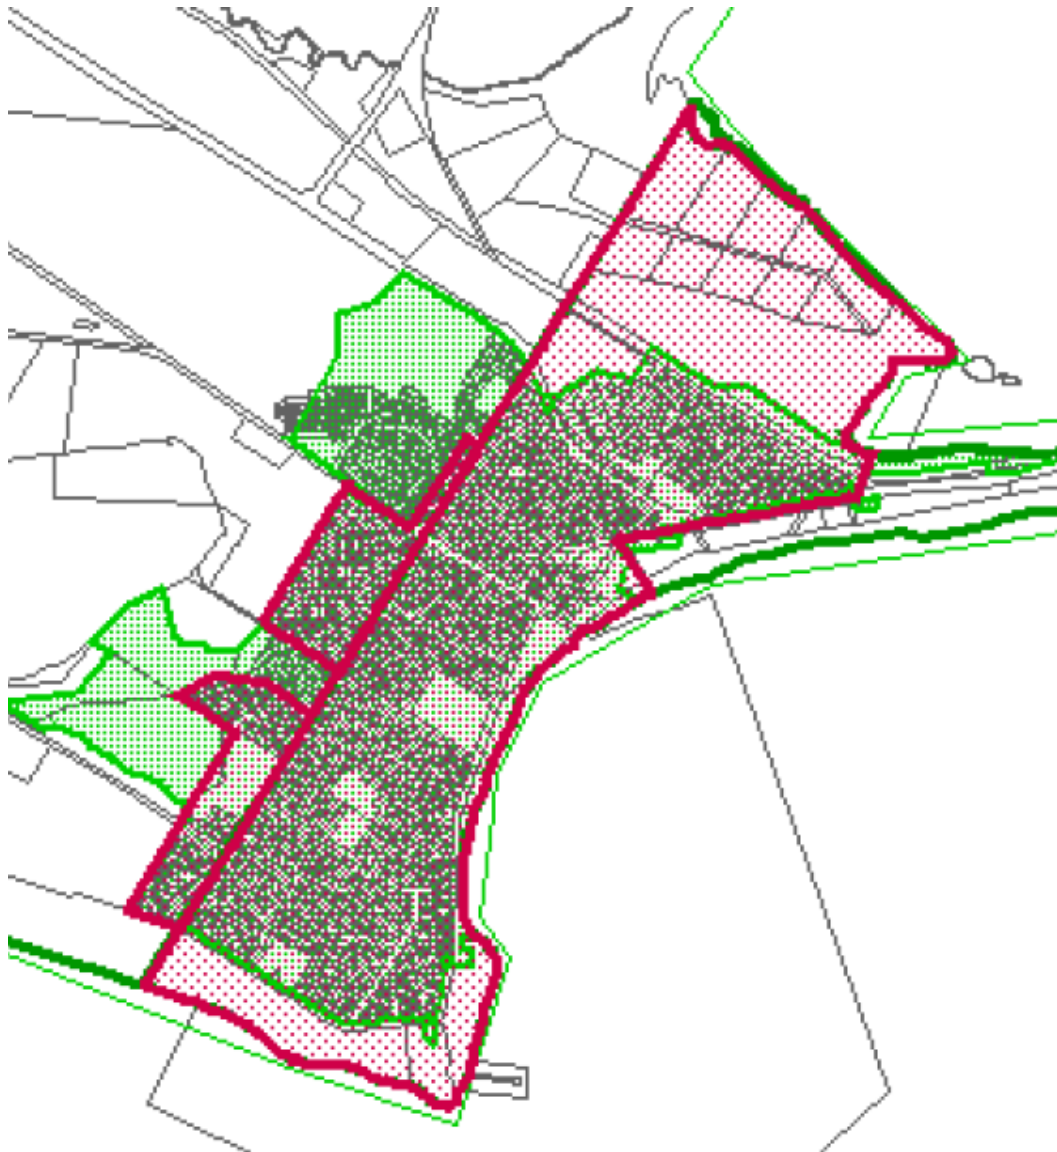
Figure 1 - HBRA Zones note areas of concern with phot GPS tag
